# #RK-1 STANDARD RADIOGRAPHIC TESTING KIT

## THE RADIOGRAPHIC KIT CONTAINS:

8 Plates, 1 Pipe & 1 Tee / Carbon Steel

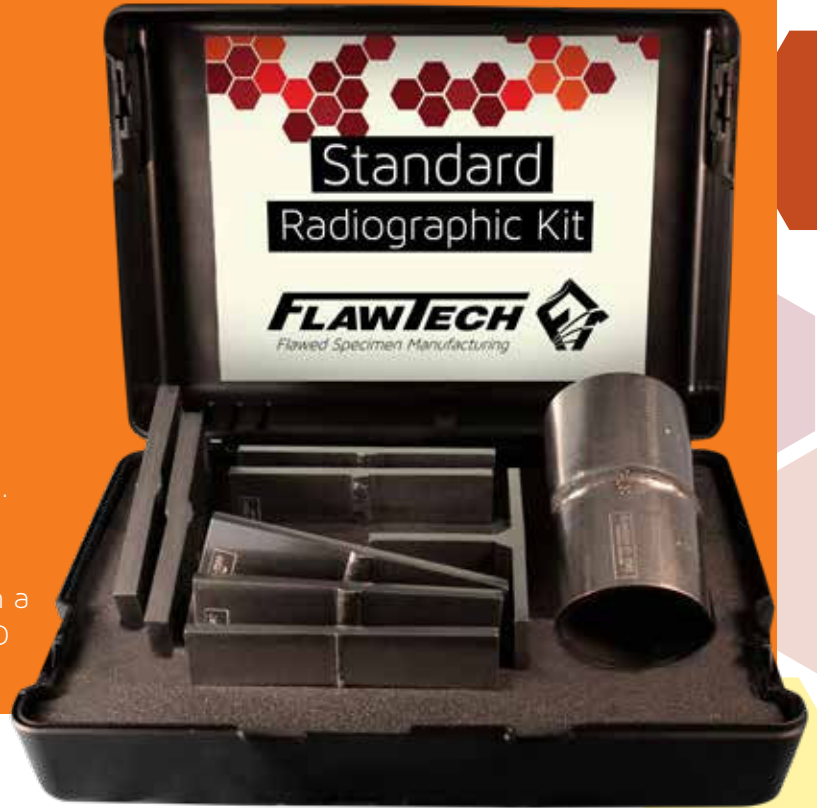
The Standard Radiographic Examination Kit contains 20 flaws similar to those shown in the cross section drawings below.

- 12 - Root Crack in SV
- 14 - Centerline Crack SV (Surface breaking)
- 15 - Centerline Crack, SV (Sub-surface)
- 30 - Porosity SV / DV
- 31 - Porosity Fillet (sub surface)
- 34 - Single Gas Pore SV
- 36 - Slag Inclusion SV (root area)
- 37 - Slag Inclusion SV (weld groove area)
- 38 - Slag Inclusion Fillet (root area)
- 39 - Tungsten Inclusion SV (root area)
- 56 - Incomplete Root Penetration SV
- 57 - Incomplete Root Penetration DV
- 59 - Incomplete Groove Weld (crown area)
- 70 - Root Concavity SV
- 71 - Excess Root Penetration SV
- 72 - Misalignment Root & Crown SV
- 90 - Weld Splatter SV
- 92 - Chipping Hammer Marks SV

See Pages 3-5 for Cross Section Views
